# *Peak Performance Home and Building Inspections LLC*

## Your Property Inspection Report

Ex, ME

Date of Inspection: 10/14/2015

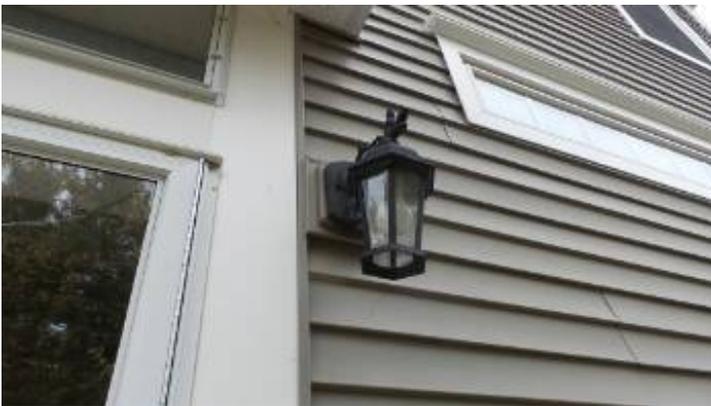
- Underground service noted.
- Main service breaker noted at electrical meter.
- Exterior GFCI outlets operated properly at time of inspection.
- Exterior light fixture is loose. Suggest securing.

Loose light fixture.

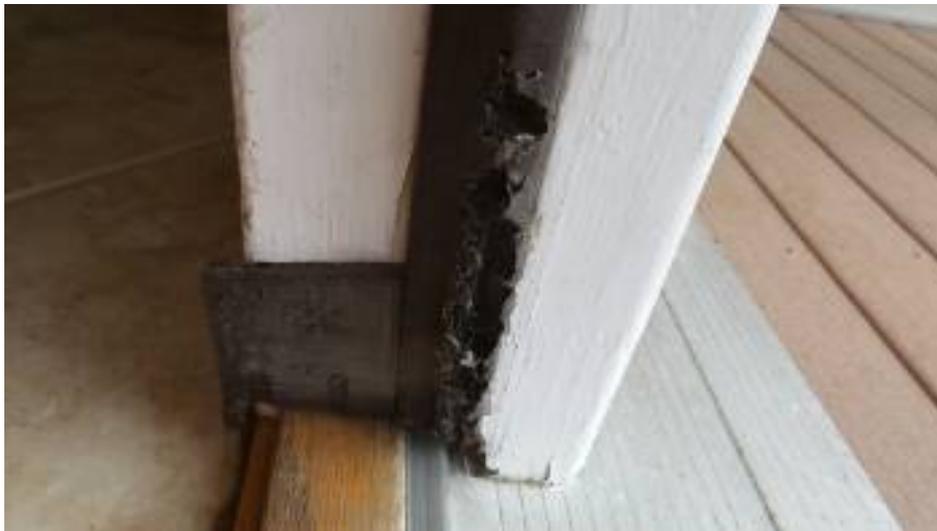
- Front door weather strip damaged.

Front door weatherstripping needs repair.

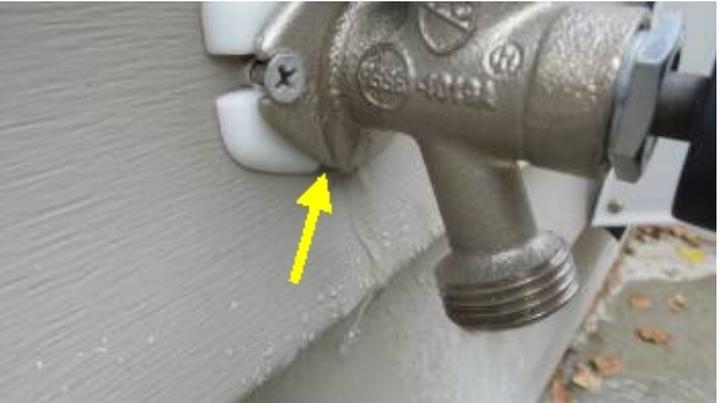
- All faucets were of the frost free type. This reduces the need to turn off the water during winter months to prevent freezing. That being said, it is still a good idea to turn them off during winter months if not in use.
- Rear water faucet leaking.

Leaking noted at rear faucet.

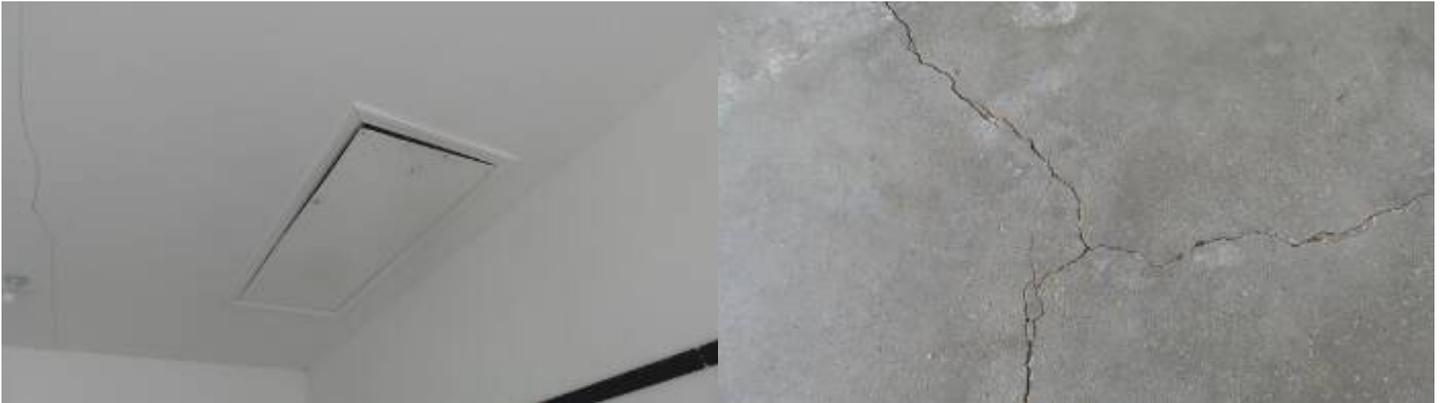
- Garage vehicle door tested properly for both auto reverse sensors and resistance.
- Minor crack(s) on garage floor. This is often a common occurrence, but should be monitored for expansion.
- **Garage-house door does not close automatically. This is to act as a fire stop, and keeps exhaust fumes out.**
- **Attic access hatch is wood material and compromises fire resistant protection. Suggest installation of 5/8" sheet rock to maintain proper fire seal.**

Attic hatch should be fired rate.

Settling cracks at floor.

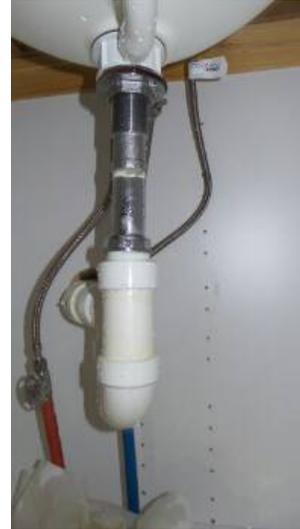
Observations: Toilet functioned properly at time of inspection.  
No evidence of active leaking at sink at time of inspection.  
GFCI trip test operated properly at time of inspection.  
Sink overflow drain is not connected, Leaking noted from the overflow.

Sink overflow drain is leaking.

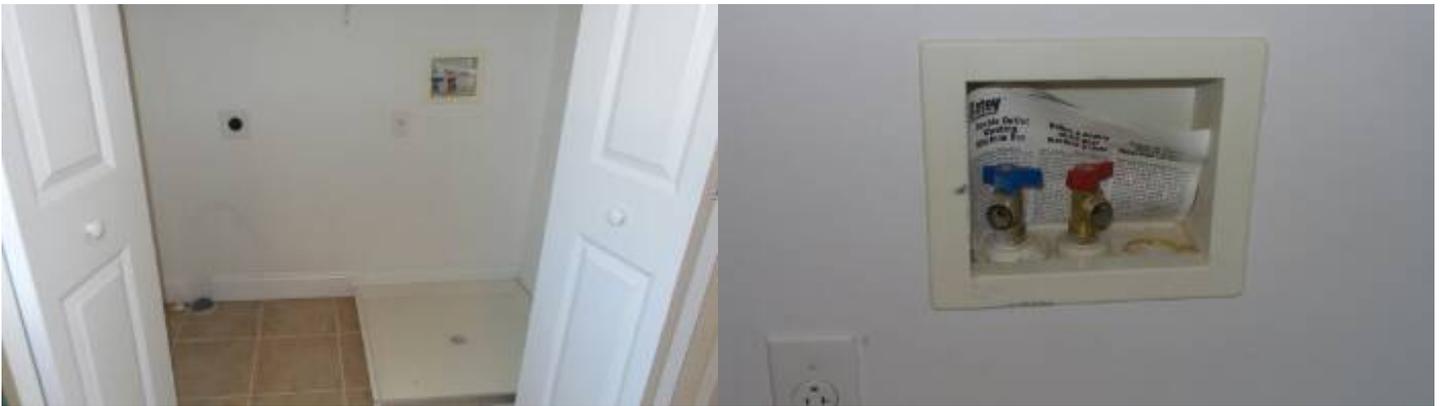
- Washing machine water supply lines lack water hammer protection. This is common in houses of this age but today's code requires this feature. It is a minor cost and I suggest adding water hammers to the supply lines.

Lack of water hammer protection.

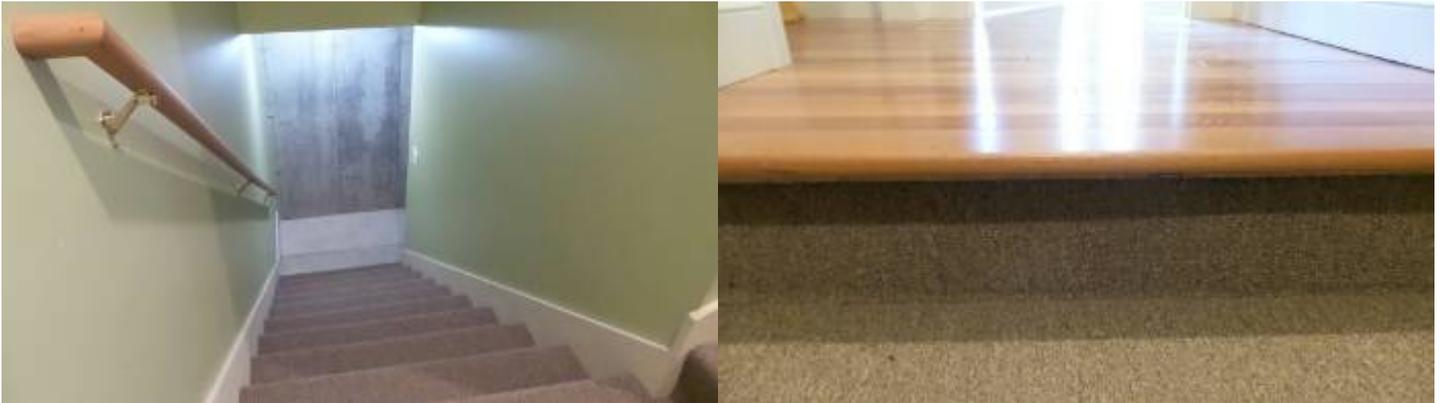
- Top steps at basement stairway, hardwood overhang. Use caution.
- No major system safety or function concerns noted at time of inspection.

Use caution at to step due to over hang.

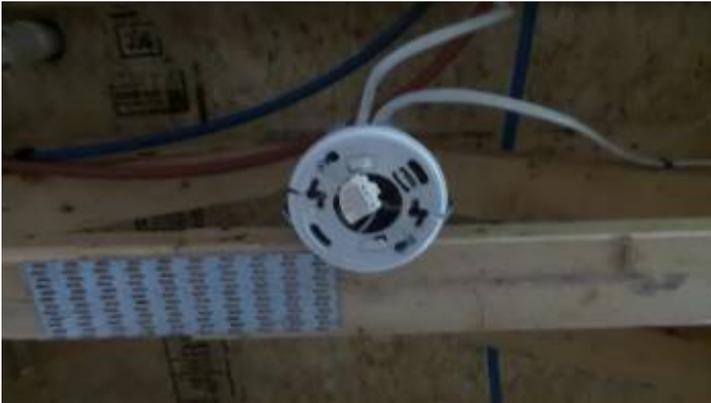
- **Some smoke detectors inoperable. Strongly recommend to install or replace for life safety reasons.**
- **Smoke detector(s) need new backup batteries.**

Missing/ damaged smoke/CO detector.

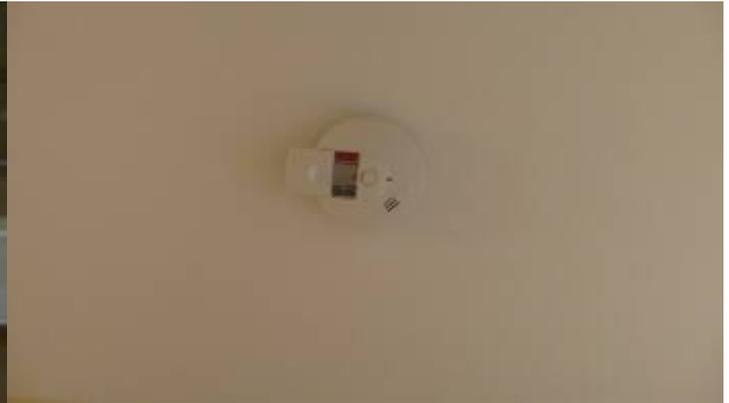
Backup batteries needed at smoke/ CO detector.

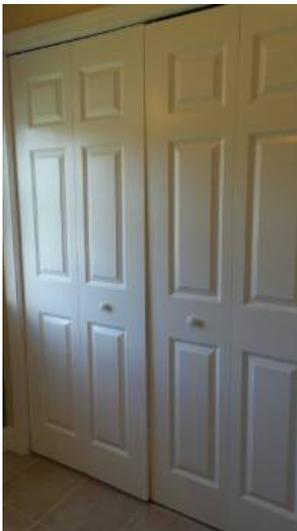
- Doors bind in jamb at the laundry and back bedroom.

Doors bind in jamb at the laundry.

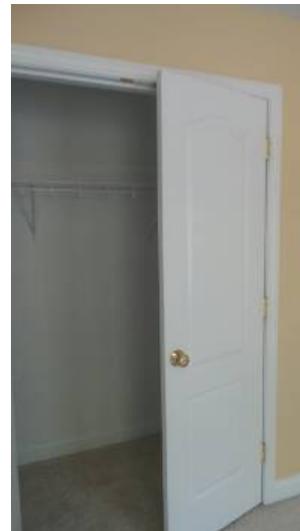
Doors bind in jamb at the back bedroom.

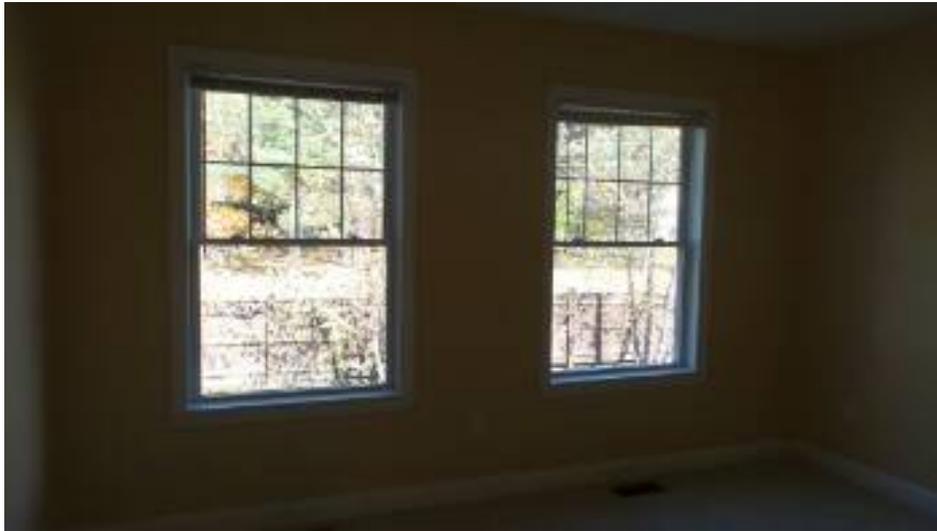
- Some window screens missing. Check with seller to determine if they are on the property.

Some window screens missing.

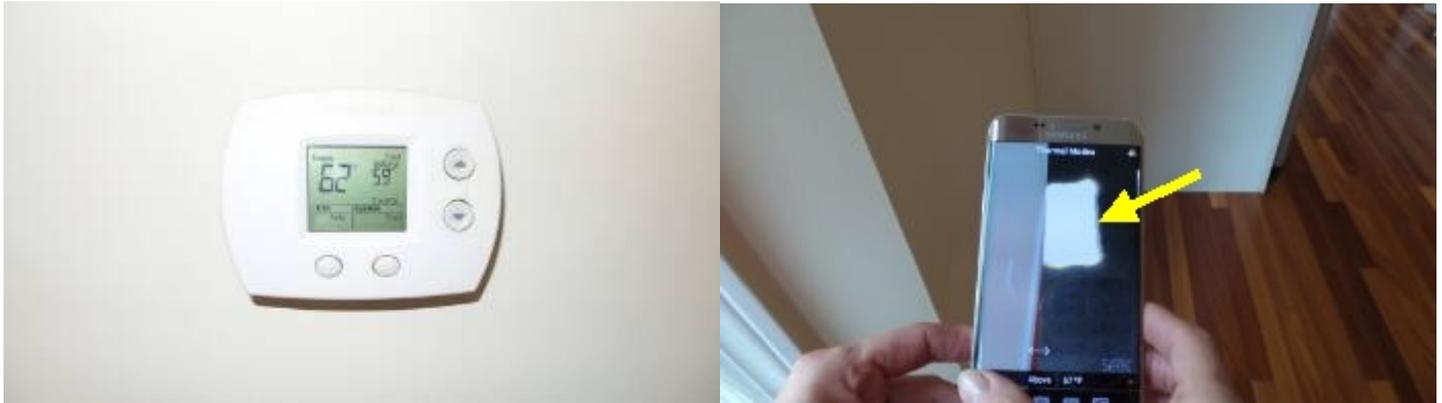
Heat did not function at time of inspection. Gas turned off.

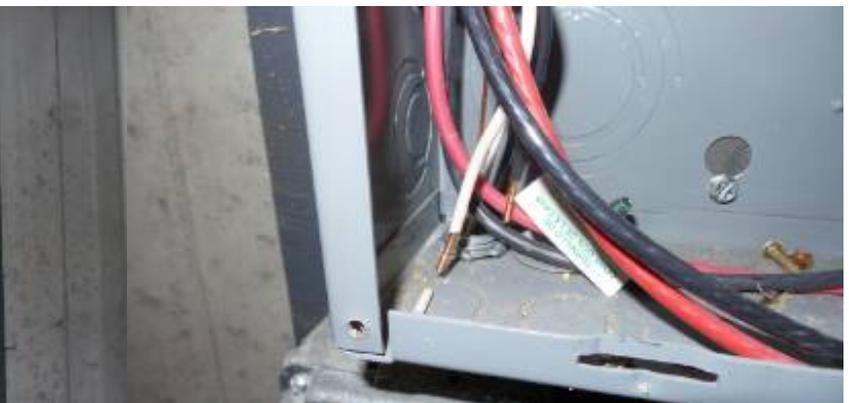
- **Exposed wire ends in panel box. Wire ends may or may not be energized, suggest further evaluation by a certified electrician.**

Exposed wire ends in panel.

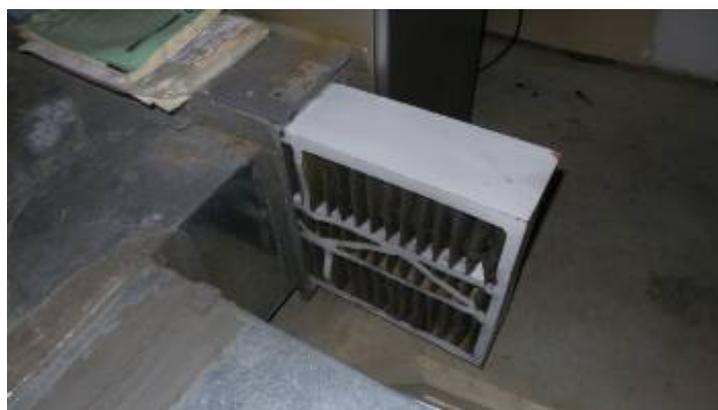
- Furnace was tested and run for minimum of 10 minutes and was found to function properly at time of inspection.
- Filter dirty and needs to be replaced.
- **No CO Detector in vicinity of furnace. Suggest installation by licensed electrician for life safety reasons.**
- **No Smoke Detector in vicinity of furnace. Suggest installation by licensed electrician for life safety reasons.**

Filter need replacement.

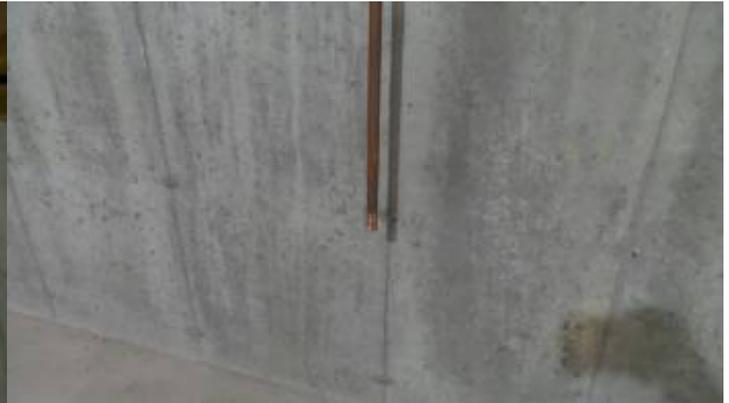
Page 22 Item: 3	Water Heater	<ul style="list-style-type: none"> <li>• <b>Temperature Pressure drain line: more than 6" from floor. One should be installed to terminate within six inches of the floor to minimize personal injury which may be caused by scalding water, in the event of a pressure blow off.</b></li> <li>• <b>No Smoke or Carbon Monoxide detector in vicinity of gas hot water heater.</b></li> </ul>

- No major system safety or function concerns noted at time of inspection.
- **Temperature Pressure drain line: more than 6" from floor. One should be installed to terminate within six inches of the floor to minimize personal injury which may be caused by scalding water, in the event of a pressure blow off.**
- **No Smoke or Carbon Monoxide detector in vicinity of gas hot water heater.**

Temperature Pressure drain line: more than 6" from floor.

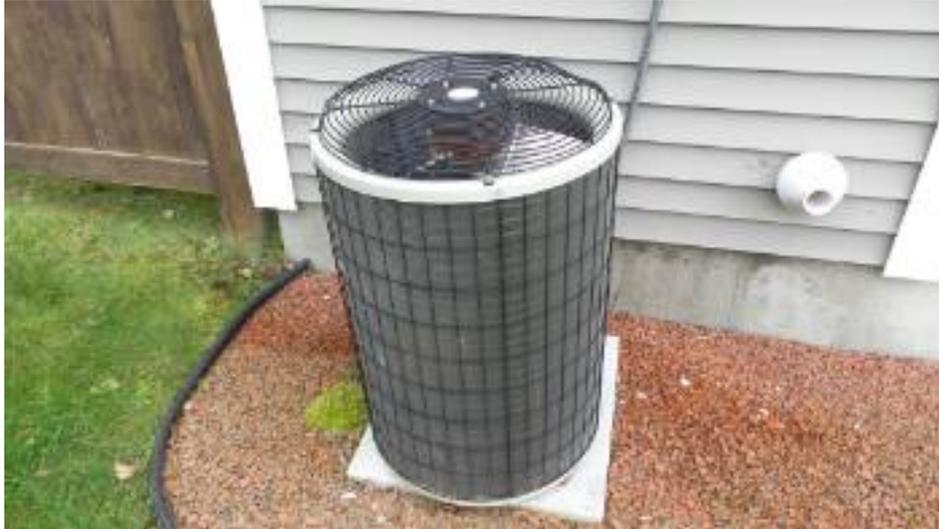
- Air conditioner base plate is not stable. Suggest leveling and securing.
- When the cooling season is over, you should cover the exterior condenser unit in preparation for winter. If it isn't being used, why expose it to the elements? This measure will prevent ice, leaves and dirt from entering the unit, which can harm components and require additional maintenance in the spring. A cover can be purchased, or you can make one yourself by taping together plastic trash bags. Be sure to turn the unit off before covering it.

Air conditioner base plate is not stable.

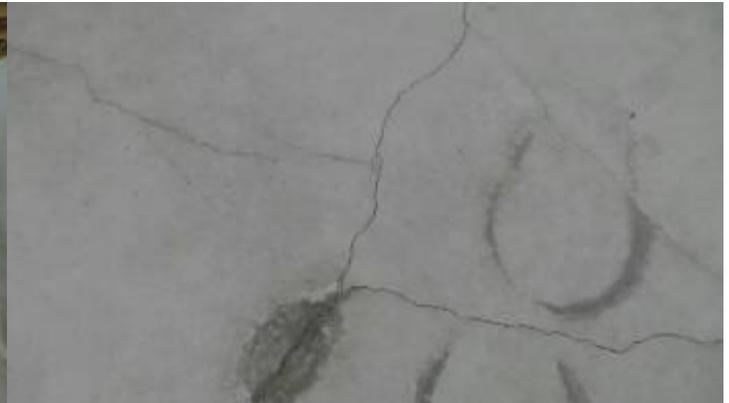
Settling cracks at floor.

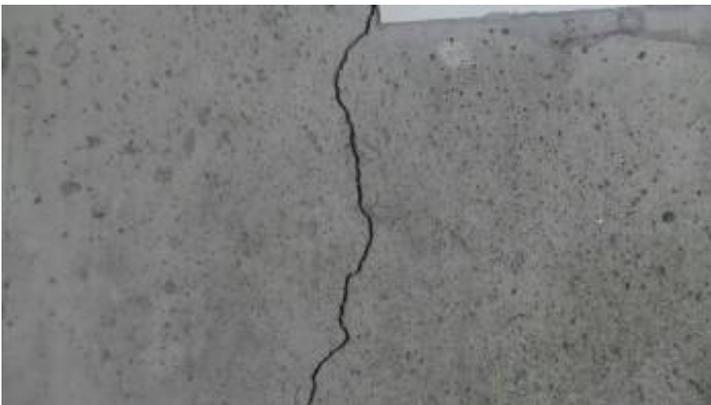
- Minor settling cracks in floor which is not uncommon. Usually these cause no problem and do not worsen with time.
- Cracks / Holes (1/4" or less) present in: foundation/ floor. Consider sealing them to prevent water infiltration. Generally speaking, cracks that are less than 1/4" are not commonly regarded as being structurally significant.
- Sealed sump pump noted, unable to check for proper function at time of inspection.
- Animal infestation is possible, due to visual traps.

Cracks / Holes (1/4" or less) present in:  
foundation.

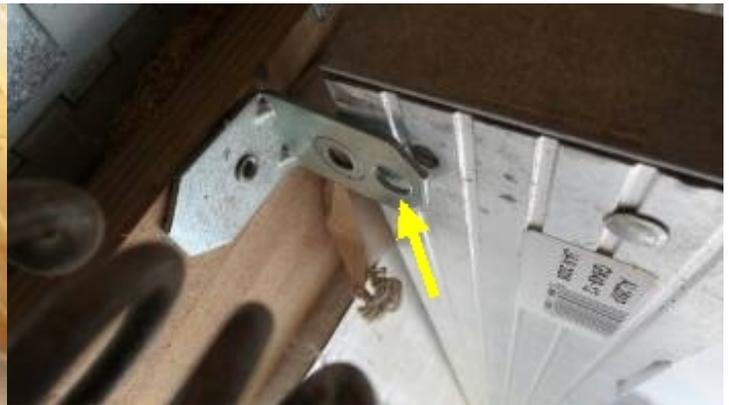
- Missing screw at top of ladder. Suggest securing. Use caution.
- Light visible at gable end. Suggest sealing to prevent the possibility of insect and water intrusion.

Missing screw at top of ladder.

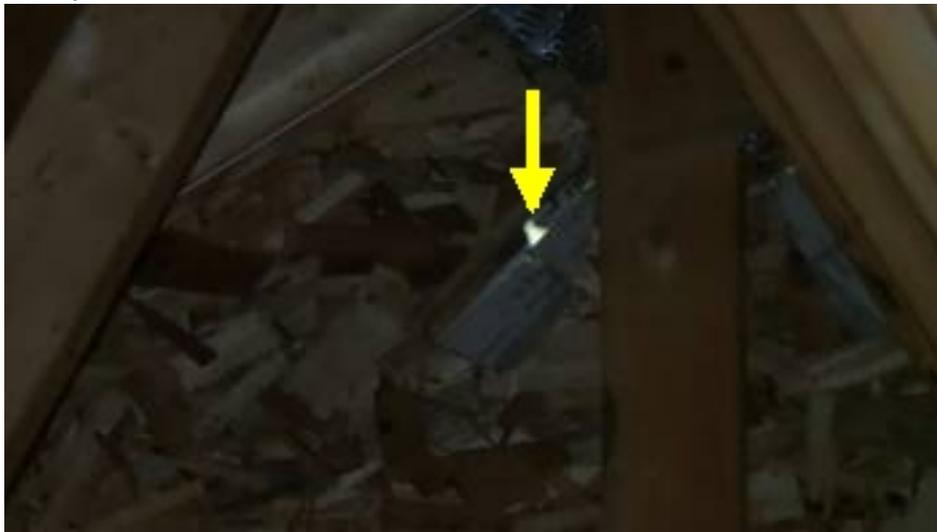
Visible light at gable end.
