# *Peak Performance Home and Building Inspections LLC*

## Your Property Inspection Report

Ex, ME

Date of Inspection: 10/14/2015

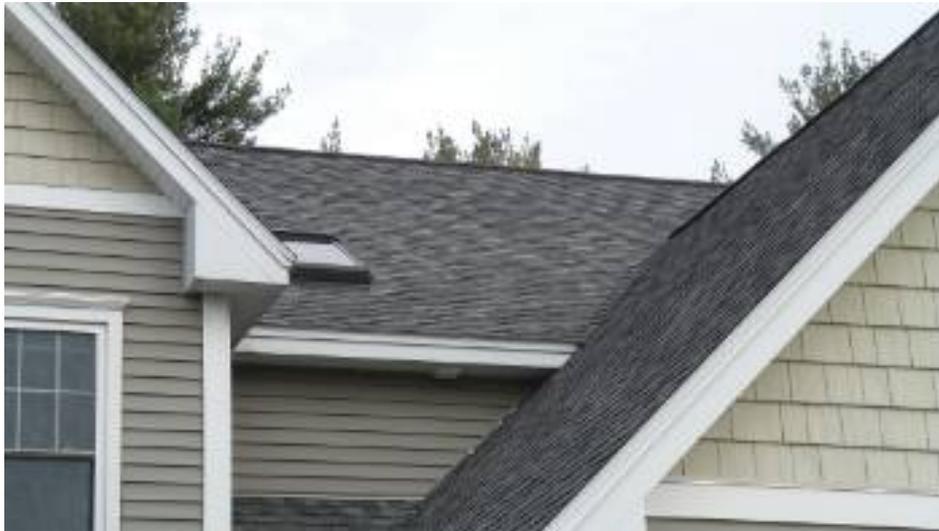
Observations: Roof has many peaks and valleys. Suggest clearing of gathered debris and snow loads to extend the life of the roof/ shingles.

Composition shingled roof.

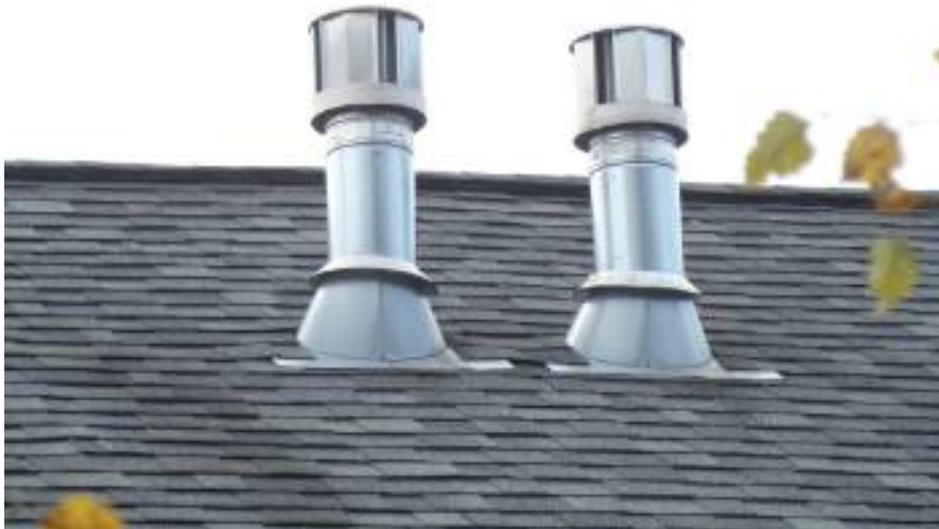
Chimney Material - Metalbestosis.

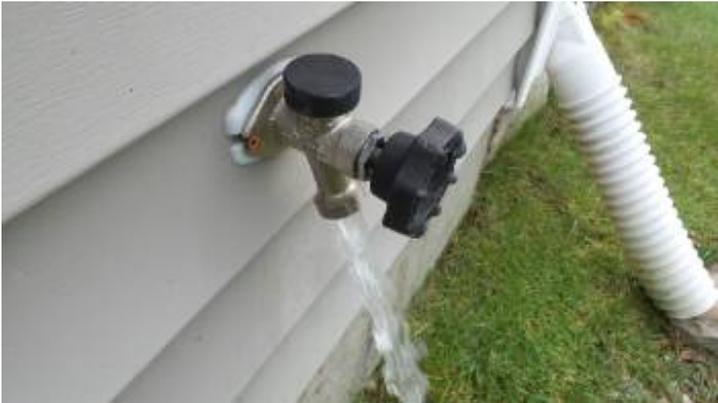
- All faucets were of the frost free type. This reduces the need to turn off the water during winter months to prevent freezing. That being said, it is still a good idea to turn them off during winter months if not in use.
- Rear water faucet leaking.

Frost free faucet(s).

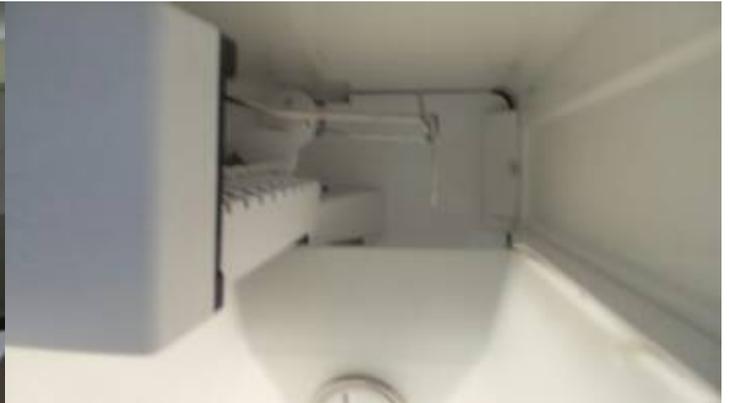
Ice lever in off position.

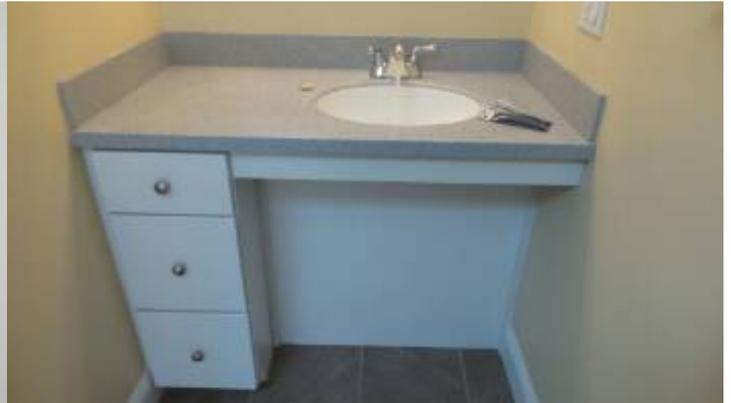
Far sink.

Observations: Toilet functioned properly at time of inspection.  
Tub and shower function properly at time of inspection.  
No evidence of active leaking at sink at time of inspection.  
Exhaust fan noted and functioning properly.  
GFCI trip test operated properly at time of inspection.  
Sink overflow drain is not connected at the far sink. Suggest repair.

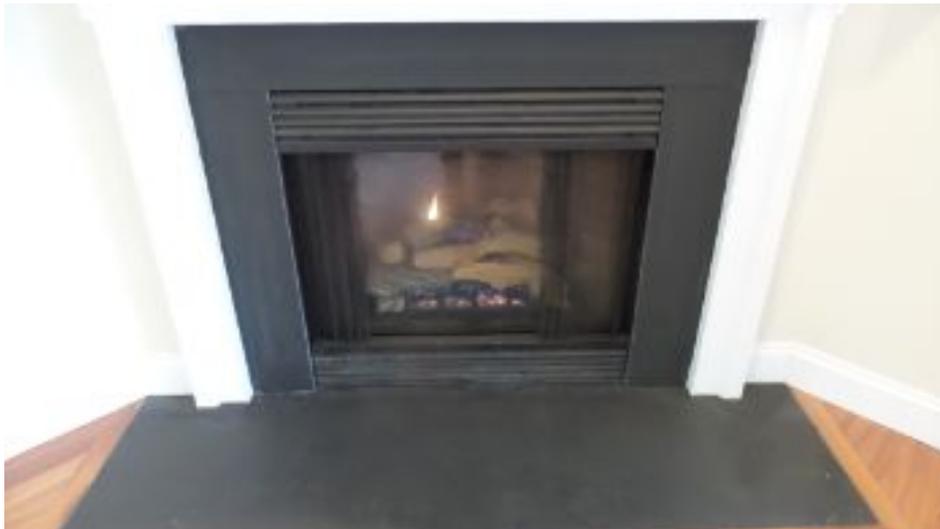
- Gas fireplace not operated properly at 2nd time of inspection.

Functioning gas fireplace.

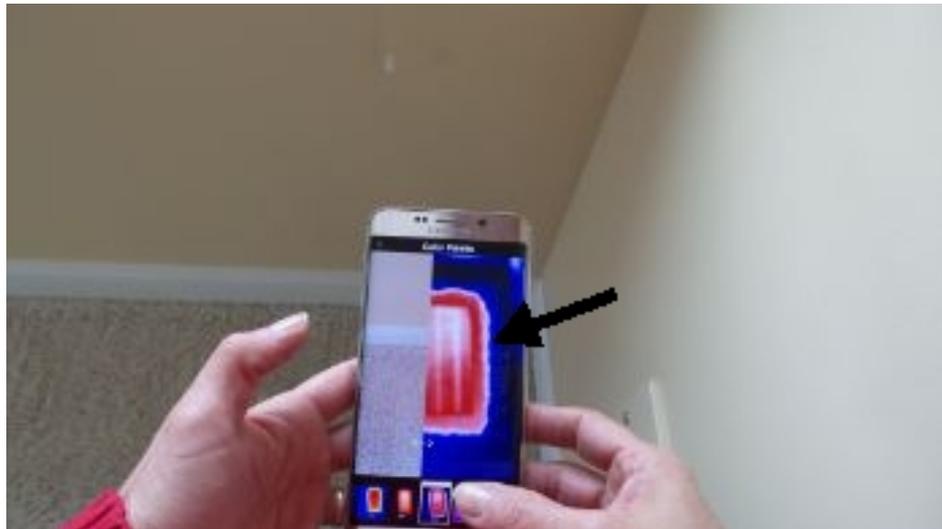
Heat did not function at time of inspection. Gas turned off.

Forced hot air functioning as seen at thermal.

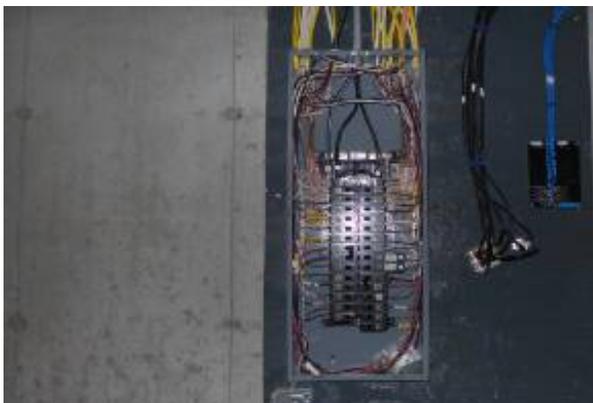
Electrical panel.

- **Exposed wire ends in panel box. Wire ends may or may not be energized, suggest further evaluation by a certified electrician.**

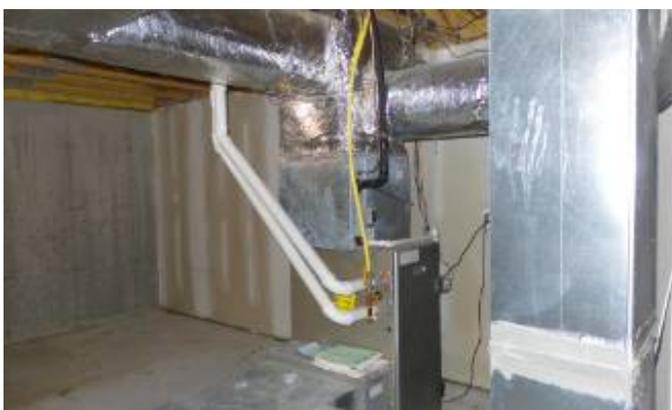
- Furnace was tested and run for minimum of 10 minutes and was found to function properly at time of inspection.
- Filter dirty and needs to be replaced.
- **No CO Detector in vicinity of furnace. Suggest installation by licensed electrician for life safety reasons.**
- **No Smoke Detector in vicinity of furnace. Suggest installation by licensed electrician for life safety reasons.**

Gas fired furnace.

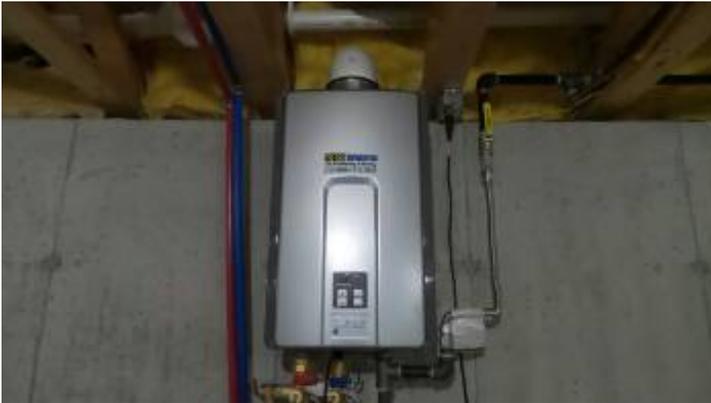
- No major system safety or function concerns noted at time of inspection.
- **Temperature Pressure drain line: more than 6" from floor. One should be installed to terminate within six inches of the floor to minimize personal injury which may be caused by scalding water, in the event of a pressure blow off.**
- **No Smoke or Carbon Monoxide detector in vicinity of gas hot water heater.**

Gas fired hot water.

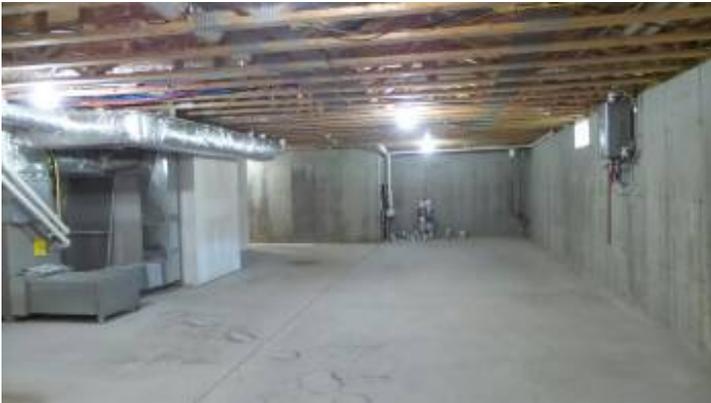
Basement.

- Minor settling cracks in floor which is not uncommon. Usually these cause no problem and do not worsen with time.
- Cracks / Holes (1/4" or less) present in: foundation/ floor. Consider sealing them to prevent water infiltration. Generally speaking, cracks that are less than 1/4" are not commonly regarded as being structurally significant.
- Sealed sump pump noted, unable to check for proper function at time of inspection.
- Animal infestation is possible, due to visual traps.

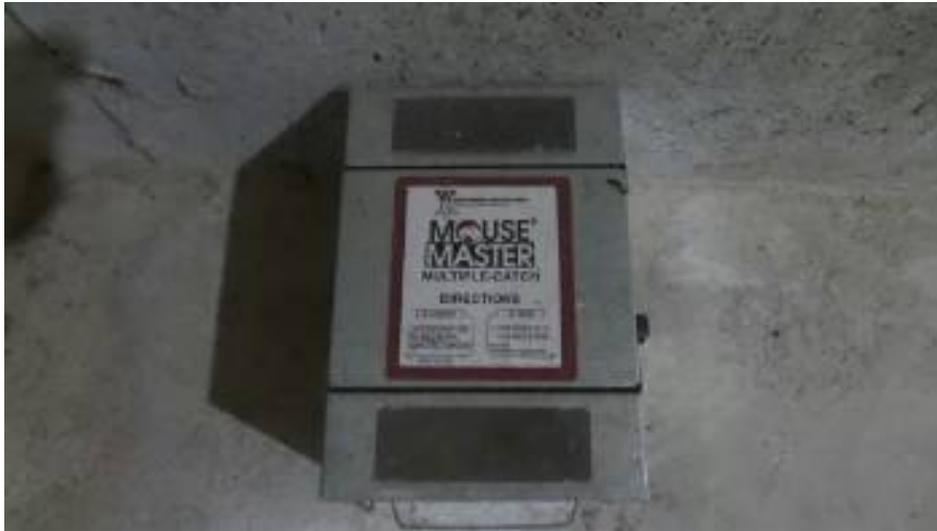
Trap.

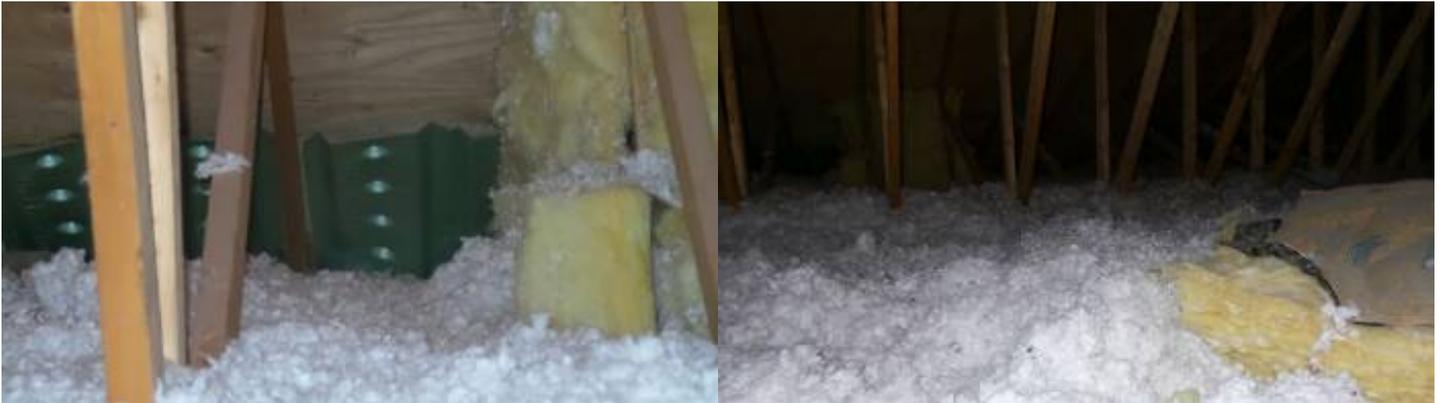
Ridge vent.

Proper vents.

Insulation.
